APPENDIX 10

LOCAL NON-DESIGNATED HERITAGE ASSETS

Assessments: Somerby Parish Local Heritage: Buildings, artefacts, parklands and gardens (using Historic England Guidance)

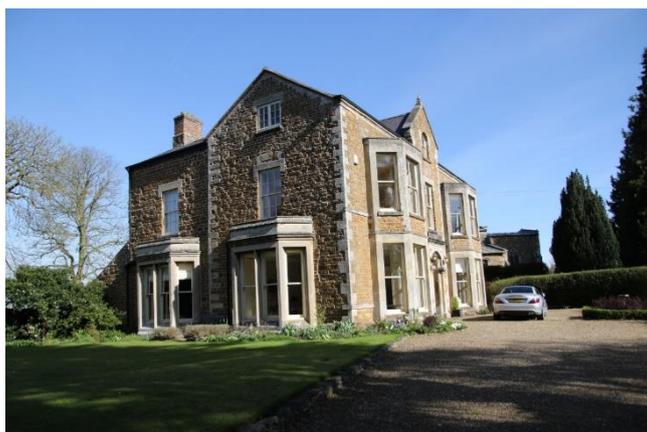
Map reference 1: The Old Rectory, Main Street:

Circa 1875, on or near the site of the C16 parsonage shown on the 1607 Brasenose College village Map; incorporation of materials from the earlier building has been suggested. The house, of coursed and squared ironstone with contrasting ashlar dressings, is a mix of C16-C17 motifs and Tudor 'classicism' including a central gable with arched window and finial, two-storey canted bays, shouldered limestone lintels, entrance porch, stone door case with pointed arch, fluted columns, and lanterns.

Figure 1: The Old Rectory, Main Street, Burrough on the Hill (Map Ref 1)

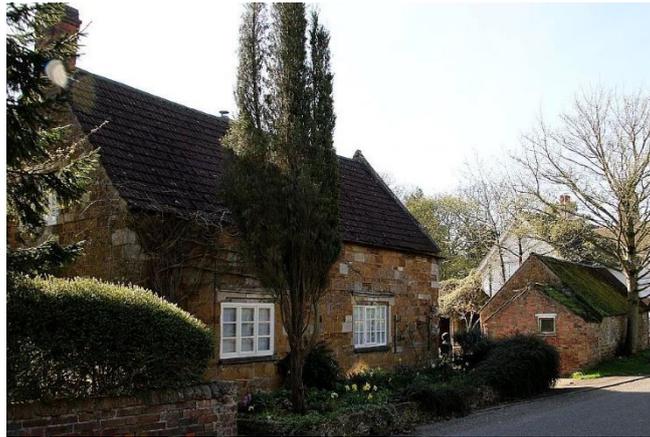
Map reference 2: Peakes farm house and stable yard, Main Street:

A village homestead circa C17 with C18 additions, on or near the site of Hely (?) Farm depicted on the 1607 Brasenose Collage Map. A measured drawing of the farm house indicates several building phases and suggests the main block of C16 origin, and/or building materials were reused from nearby Owston Priory (dissolved 1536-9). There is no written report accompanying the drawing. L-shaped, of coursed and squared ironstone, the building is vernacular in style; outbuildings enclose the service court. The west and south elevations contain windows with ovolo moulding, and hoods, popular through the late C16 and C17, the mullions later replaced by wood glazing bars. (Source: Mr. Brian Blayney, RIBA FLI, undated measured drawing.)

Figure 2: Peake's Farm House, Main Street, Burrough on the Hill (Map Ref 2)

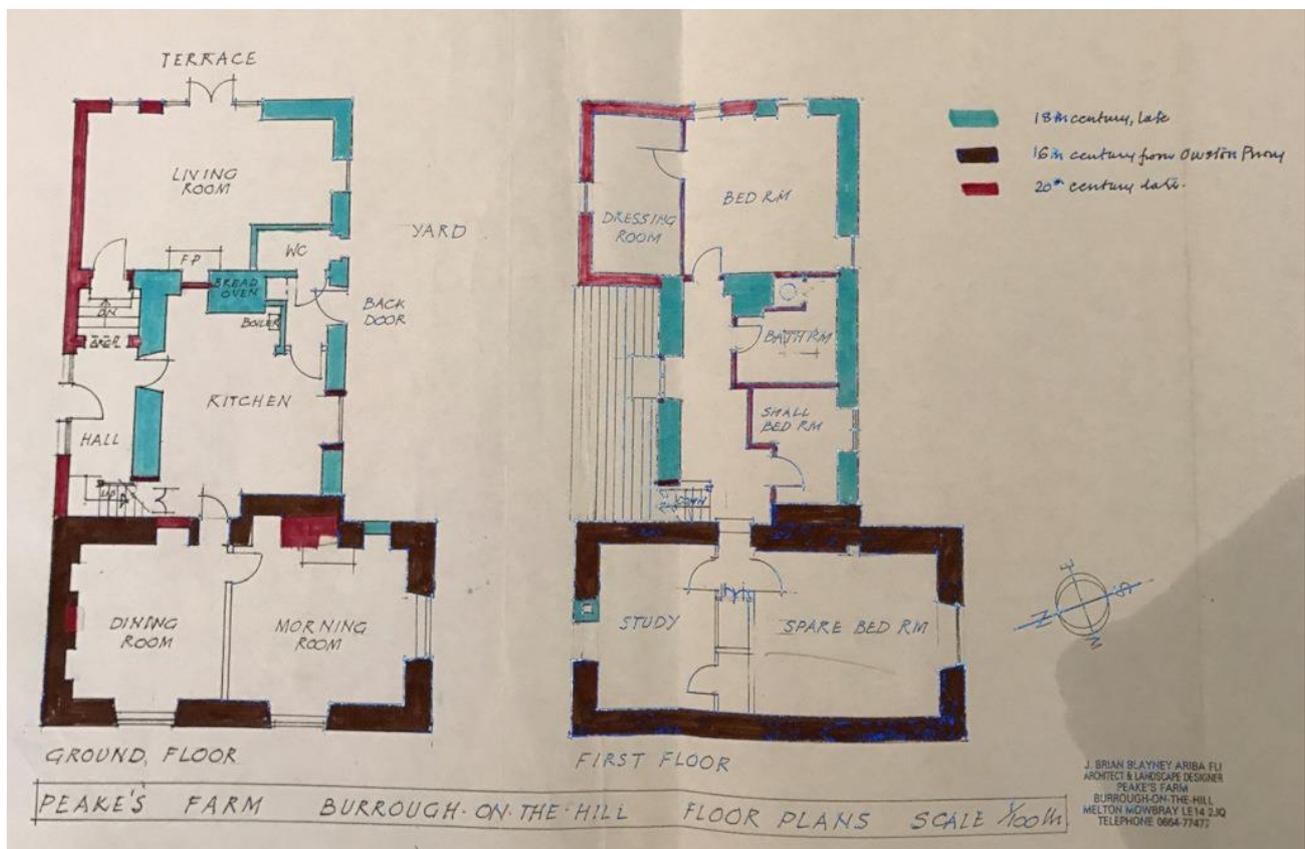
Figure 3: Plan of Peake's Farm showing the different phases of construction and sources of building materials, Main Street, Burrough on the Hill (Map Ref 2)

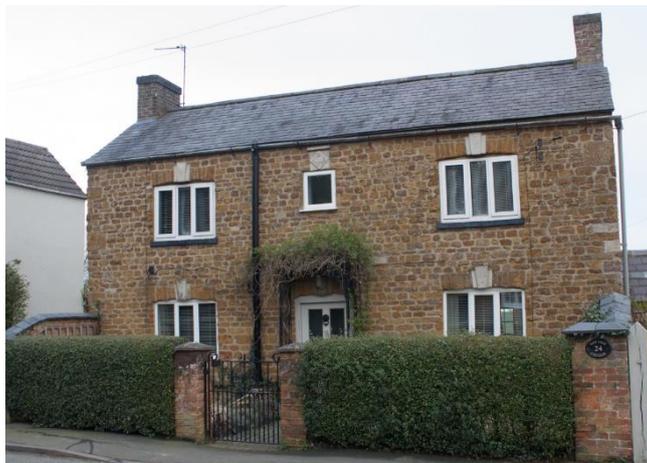
Map reference 3: Yew Tree Cottage, Main Street:

Small picturesque-style ironstone cottage, date stone of 1815, with keystones set into segmented ironstone arches over entrance and windows, with modern remodelled windows and glazing bars.

Figure 4: Yew Tree Cottage, Main Street, Burrough on the Hill (Map Ref 3)

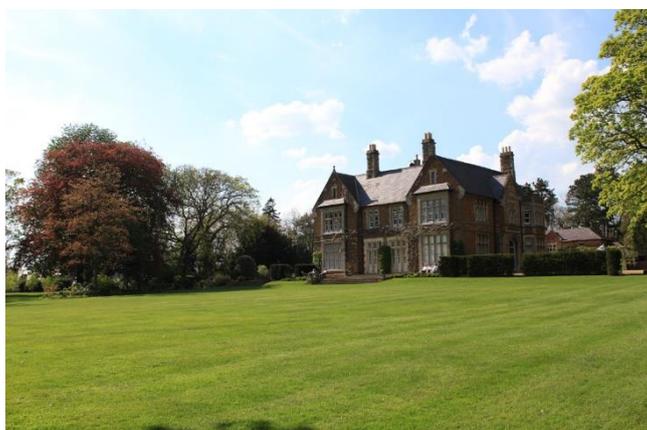
Map reference 4: Burrough Hall, Burrough Road:

Built by 1876 on high ground north-east of the village by C.W. Chaplin, businessman and Member, Leicestershire Architectural and Archaeological Society. The house can be characterised by its fine Tudor revival style and fenestration. Three bays and a service wing, coursed and squared ironstone with ashlar dressings, mullion and transom windows, and finials on principal gables.

The front elevation with gabled entrance porch, stone door case, pointed arch, carved hood, first floor 6 light windows and date stone. To the right of the entrance, flat-topped canted bay with 6 x 3 lights. The rear (west) elevation, asymmetrical with oriel window. The south elevation overlooking the garden is symmetrical, with a two storey band of windows, canted end gables with bay windows, and centred glazed doors which repeat the style of the windows. (Sources: British History Online: Burrough on the Hill; Minutes of The Leicestershire Architectural and Archaeological Society, January, 1896, ed. Brown, C., University of Leicester)

Figure 5: Burrough Hall, Burrough Road, Burrough on the Hill (Map Ref 4)

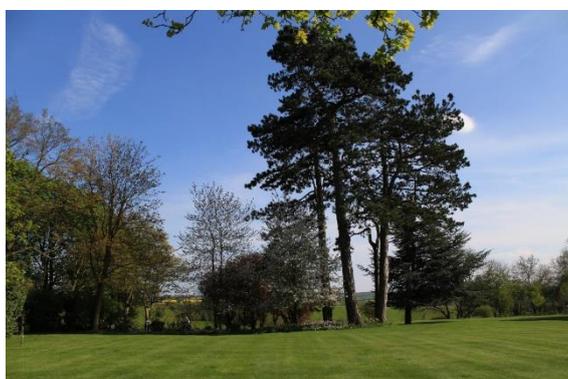
Figure 6: Burrough Hall Park and Garden, Burrough Road, Burrough on the Hill (Map Ref 4a)

Burrough Hall, located above the south and west slopes of the Burrough Hill escarpment, is approached through park land bordering Somerby Road. The park is sheep pasture with scattered field trees, some veterans; an avenue of trees lines the drive; a designed 'pinery' situated on the north-west side of Somerby Road, partially overlooking Burrough Hill Fort (SAM). Natural England has designated areas of the park and gardens as Priority Habitats.

The pleasure garden, designed for views, is laid out in lawns, planted with groves of mixed native species and conifers, some veterans, clipped shrubs and naturalized plantings. Sweeping views over countryside are orchestrated from the garden towards Burrough Grade II* Church, Whatborough Hill (SAM) and Somerby Grade I Church. Areas of the garden were re-designed in 2007. Public views of the park and/or garden are had from the Burrough Road, footpath D70 and the garden is opened to the public as part of the National Garden Scheme. (Source: British History On-Line: Burrough)

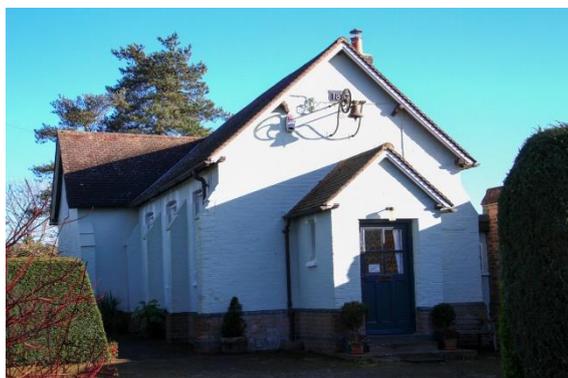
Map reference 5: The Old School, Main Street:

A National School built by subscription in 1873; brick construction and in Domestic Revival style, maintaining original bell and pulley system, panelled door with pointed arch and original set of door keys. One of four mid to late C19 National Schools in the parish (two in Somerby), it has group value with national schools in Pickwell including Grade II Somerby County Primary School. Now sympathetically remodelled to a dwelling, it has social and landmark value to the community. (Sources: British History On-Line: Burrough; Victoria County History, vol. 5, 1964).

Figure 7: The Old School, Main Street, Burrough on the Hill (Map Ref 5)

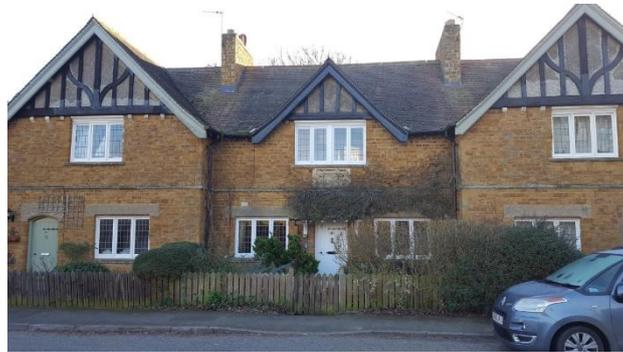
Map reference 6: Brasenose Estate Cottages, no. 38-43 Main St:

Two groups of stone-built cottages built in 1907-9 by Major A. Coats, occupant of Burrough Hall, they represent a fine example of Domestic Revival style cottages, constructed of brick and partly faced with coursed and squared ironstone masonry or stuccoed, with moulded string course, timber framed and decorated gables, barge boards, casement windows and panelled doors with wrought iron strap work and limestone shouldered lintels. (Source: British History Online: Burrough on the Hill).

Figure 8: Brasenose Estate Cottages, Main Street, Burrough on the Hill (Map Ref 6)

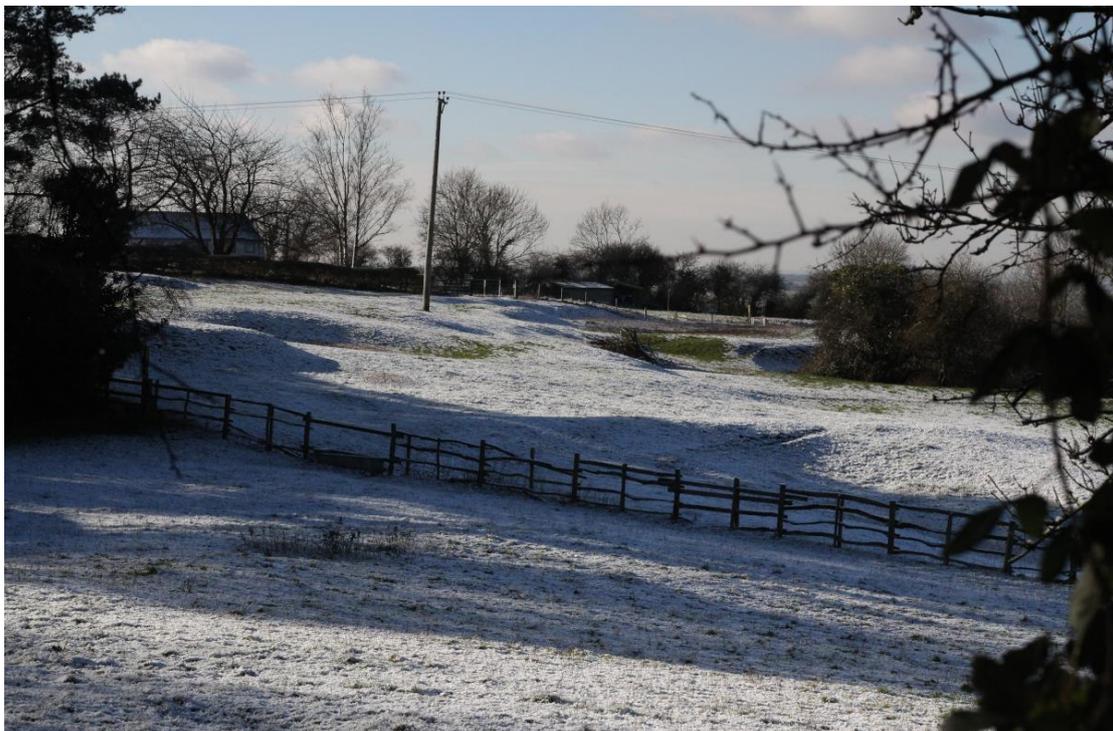
Map reference 7: Medieval earthworks, Melton Lane and earthworks west of Church:

A distinct area of earthwork remains including C17 terraced gardens, artificial ponds associated with a late medieval Manor, circa 1569 (Nichols's 1798 County History) and likely earlier, demolished in the 1830's; and tracks, a quarry and building platforms adjacent to St. Mary's Church to the north. The buildings and garden are represented on the 1607 Brasenose College map. (Source: MLE: HER 4062 and 4063).

Figure 9: Area of Medieval Earthworks, Melton Lane, Burrough on the Hill (Map Ref 7)

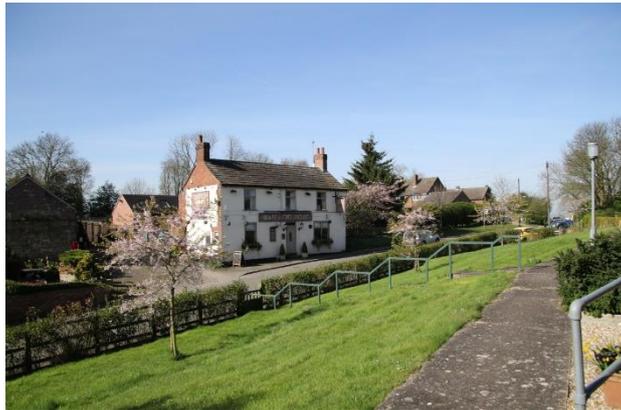
Map reference 8: The Stag and Hounds and outbuilding, Main Street:

Early C19 pubic house, with a number of building phases including a modern extension. The north-east (front) elevation is refaced with brick; the south east elevation is also of brick (possibly late C19/early C20); the north elevation is of squared and coursed ironstone. To the rear a lower, earlier two storey wing of coursed rubble stone, in the local vernacular style with wood framed casement windows. The building is of landmark value to the community for historic and social reasons. Adjacent to the pub is a brew house which currently produces popular local artesian beers. (Source: British History Online: Burrough).

Figure 10: The Stag and Hounds, Main Street, Burrough on the Hill (Map Ref 8)

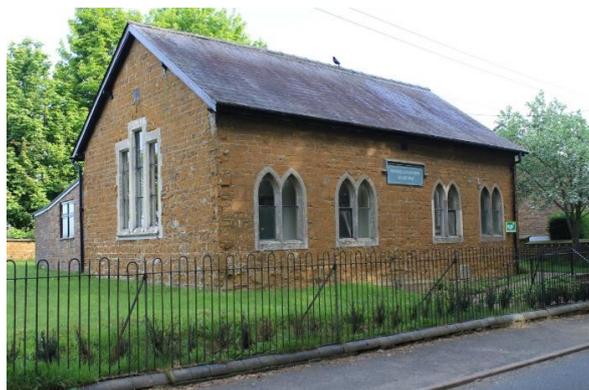
Map reference 9: Pickwell National School, Somerby Road:

The earliest of four national schools in the Parish, built by 1835, remodelled in 1883; constructed of coursed and squared ironstone in Gothic Revival style. Features include a panelled door with pointed arch, wrought iron strap-work and decoratively carved limestone spandrel. There are four two-light lancet windows, and two square headed casement windows with central stone king mullion and decorative ashlar surrounds. The stonework surrounding the windows suggest an architectural relationship with other Pickwell estate buildings including Home Farm, Wingfield House and Grade II Pickwell Manor, itself remodelled in the C19. The building is bounded on three sides with a low ironstone wall stopped by pillars and a roadside wrought iron rail and gate. The building is now used as the village hall. (Source: British History Online: Pickwell).

Figure 11: Pickwell National School, Somerby Road, Pickwell (Map Ref 9)

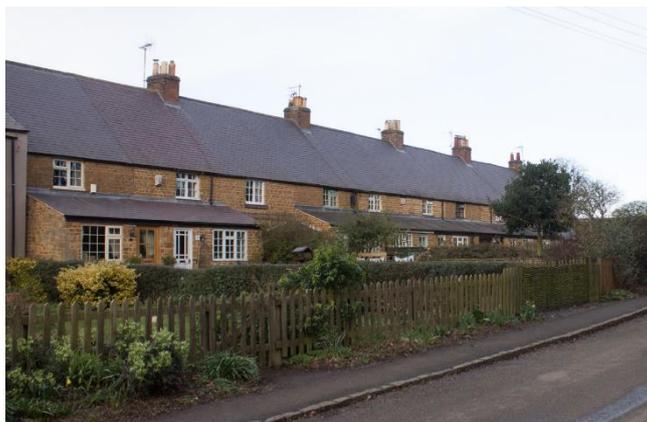
Map reference 10: Stone Pit Terrace, Main Street:

Date stone 1870, and built by Richard Fryer, occupant of Grade II Pickwell Manor. There are ten attached two-storey estate cottages, built of local ironstone in the vernacular style, set back from the Main Street with picket fenced enclosed front gardens. The cottages are adjacent to the earthworks of gravel or sand pits last used during the late C19, and the site of a limekiln (now demolished). They are a good example of worker accommodation adjacent to an early industrial site and the Manor. The disused quarry is locally designated as a Site of Environmental Significance (PH-01) in the Neighbourhood Plan. (Source: British History On-Line: Pickwell; Somerby Remembered, 1994, Local History Society)

Figure 12: Stone Pit Terrace, Main Street, Pickwell (Map Ref 10)

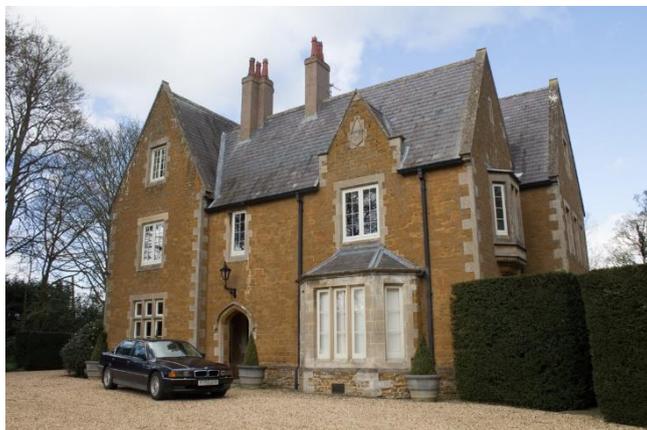
Map reference 11: The Old Rectory, Main Street:

The Old Rectory is a fine example of domestic Gothic Revival style. It was built circa 1856 adjacent to the site of the former C17 (or earlier) All Saints rectory, now demolished but depicted on the 1616 Pickwell Manor estate map. It is of two storeys with attics, with steeply pitched roof, of coursed and squared ironstone with ashlar dressings; the front elevation, three bays with two gables asymmetrical in height, one with a single storey canted bow window. The stone door cases have pointed-arches and carved stops; a decoratively carved oriel ornaments the first storey of the east elevation. It is the former rectory for Grade 1 All Saints Church and the house and garden is a feature in its setting. (Source: HER: MLE15203 - amended; 1616 Map of the Manor of Pickwell, LRO, Collection T1797)

Figure 13: The Old Rectory, Main Street, Pickwell (Map Ref 11)

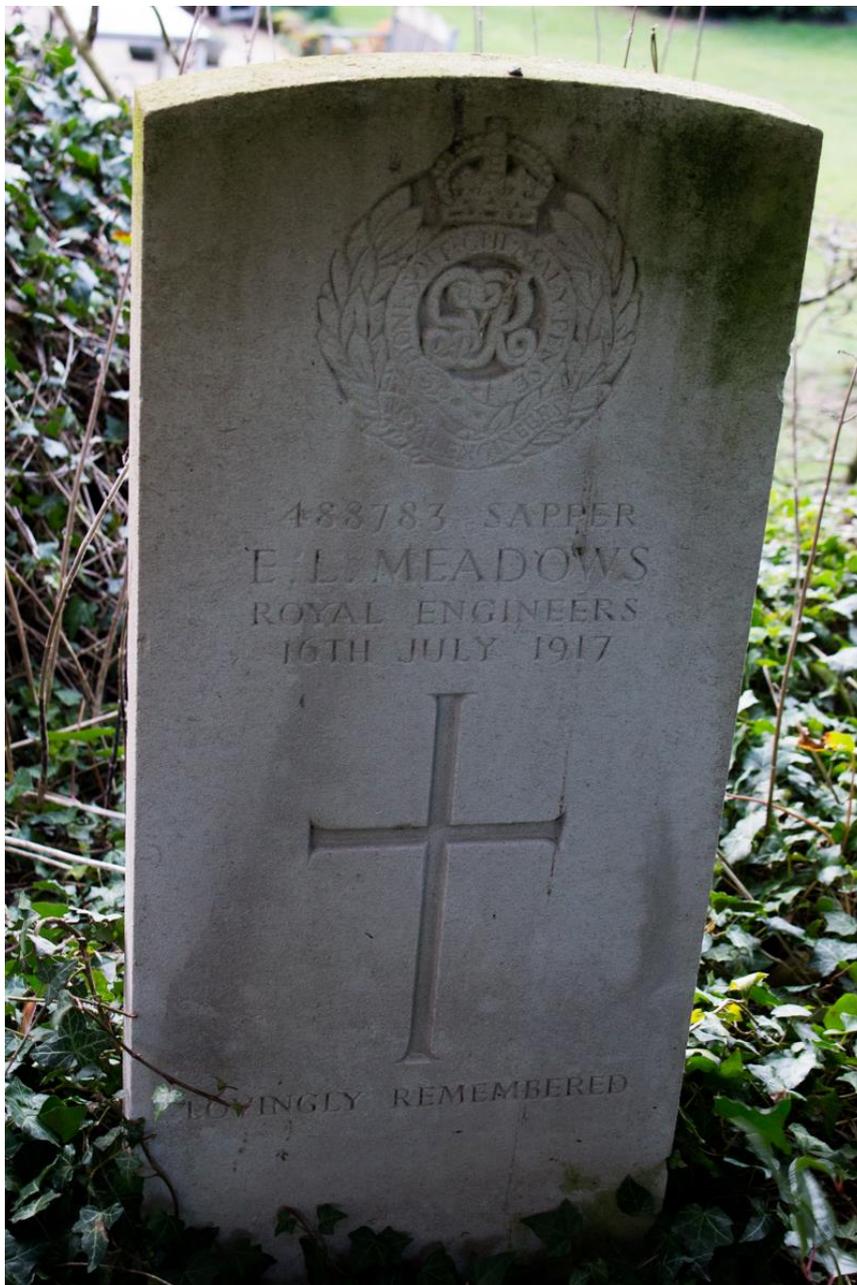
Figure 14: Pickwell Closed Churchyard (Map Ref 12)

Great War headstone, Sapper Edward Luke Meadows, Royal Engineers, 16th July, 1917, located at centre west end of the closed church yard. Sapper Meadows, a resident of Somerby, member of the Primitive Methodist congregation and a painter and decorator, was commemorated by Parish residents on the centenary of the end of World War I held on November 11, 2018. The grave stone is of communal value. (Source: Leicestershire County Council War memorials Project)

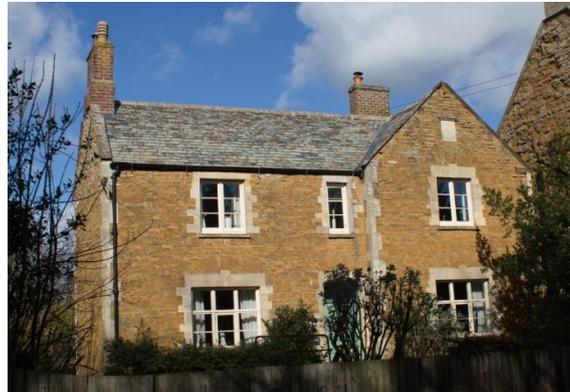
Map reference 13: Wingfield House, Main Street:

Two storey dwelling coursed and squared ironstone, with single canted bay with gable, limestone dressings and date stone of 1884. Domestic Revival in style, the front elevation has square headed windows with decorative ashlar surrounds, inset key stones and segmented brick relieving arches

above; the entrance, a stone door case with four centred arch, fluted jambs, carved stops and six panelled wooden door. The locally distinctive style of the window surrounds, repeated on Home Farm house, Pickwell National School (remodelled 1883) and the C19 facade of Grade II Pickwell Manor, suggest a relationship by period and/or builder and architecture. Wingfield House is recorded as the dwelling of the Pickwell bailiff who in a rural area may have, with other duties, managed the estate lands of adjacent Pickwell Manor. (British History On-line: Pickwell)

Figure 15: Wingfield House, Main Street, Pickwell (Map Ref 13)

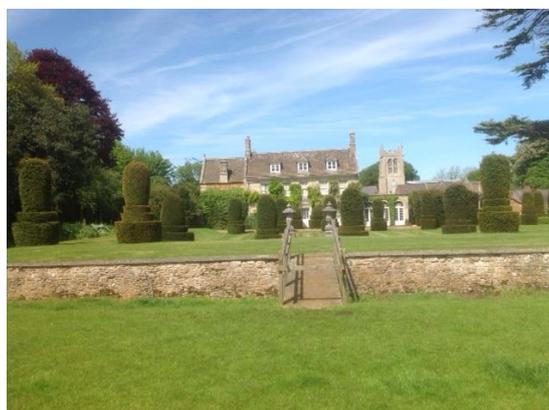
Figure 16: Pickwell Manor Park and Garden, Somerby Road, Pickwell (Map Ref 14)

The park and garden is the setting for Grade II Pickwell Manor, an early C17 dwelling with C18 and C19 additions (HE Listing 1177724) and for Pickwell Grade I Church. Estate maps from 1616 and 1736 provide a record, rare in the Parish, of the evolution of Pickwell Manor park, garden and house. The drawings suggest a C17 principal entrance and series of polite rooms at the south of the house, with gardens at the south and east as at present. The position of the 1616 orchard or designed tree planting, at the east, is preserved by a contemporary parterre. The larger garden at the south evolved to lawns, with viewing banks and specimen trees added during the C19-early C20. A late C20 castellated folly in the kitchen garden is constructed with reused stone from Burley House, Rutland. A Ha-ha (mid-C18 or later) and coped ironstone walling separates the lawned gardens from the park. Views to both Pickwell and Somerby Grade I churches are garden features. Footpath D68 provides public views of the park and garden which have communal value for their visual qualities and usage as a site for social functions by the Parish. (Source: Map of the Manor of Pickwell, LRO: Collection T1797 (1616 map) and Collection T1798 (1736 map)).

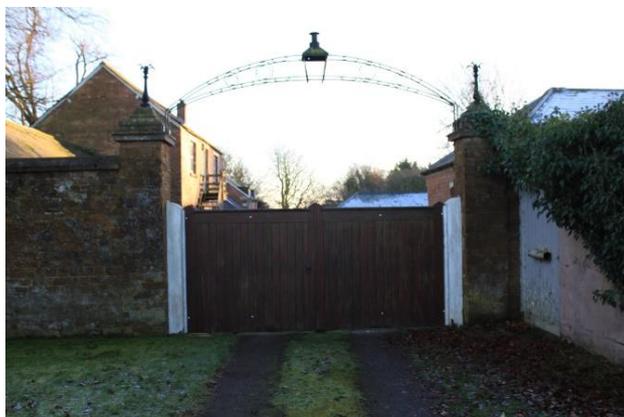
Map reference 15: Gateway to Firdale Farm and former Somerby House (Grade II) stables, High Street:

Mid to late C19 gated entrance, to stables and service buildings likely of the same period, represented on 1885 Somerby OS map. The gateway comprises two ironstone pillars with decorative metal lamp posts on each, and a wrought iron arch (late C20) with a central lantern. One of four surviving gateways associated with the village's three country houses, and a feature in the settings of Somerby Grade I Church, and Grade II Somerby House with which the gate has historic and architectural group value. (Source: 1885 Somerby OS Map)

Figure 18: Gateway to Firdale Farm and former Somerby House (Grade II) stables, High Street Somerby (Map Ref 15)

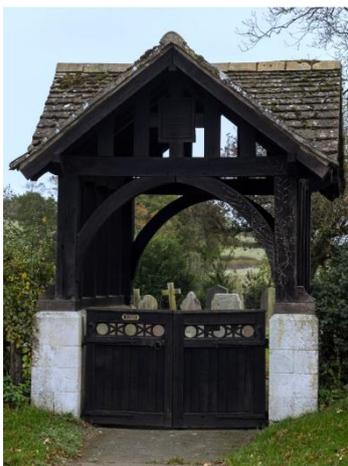
Map reference 16: The Lychgate (1924), Somerby Cemetery, Town End Road:

Late Domestic Revival period, of pegged timber post and beam construction, set on a stone plinth, with a pitched slate roof with four cross gables; the wooden entrance gate is decorated with carving and iron strap work. It is inscribed 'In Memoriam. 1924. Charles Edward Erroll Hay'. Lieutenant Hay, only son of Charles Hay, occupant of Grade II Somerby House, served in the Great War from 1914-17. Killed in action and buried in Crouy France in August 1917, the Lychgate and a second memorial in Somerby Grade I church remembers him. The Lychgate has historic associations with Grade II Somerby House. (Source: Leicestershire War Memorials)

Figure 19: Lychgate, Somerby Cemetery, Town End, Somerby (Map Ref 16)

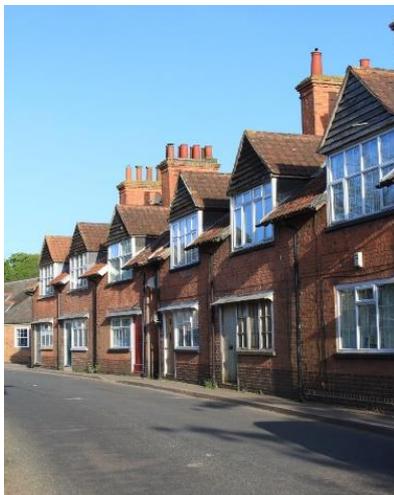
Map reference 17: Grove Cottages, High Street:

Six attached cottages located on the High Street built circa 1912-14 in Domestic Revival style by Samuel Hames to accommodate staff working at Hames's commercial stables at the Grove. (See Map references 25-27). Constructed of red brick, they feature steeply pitched roofs with red pantiles, generous first storey fenestration, symmetrical dormers with timber decoration and distinctive matched chimney stacks. One observed internally, retains original tiled and cast iron chimney pieces. They have a clear architectural and historic relationship with Grove stables, water tower and the Grade II Vinery at the Grove. (Source: HER: MLE22268; Hames Family Archives, private)

Figure 20: Grove Cottages, High Street, Somerby (Map Ref 17)

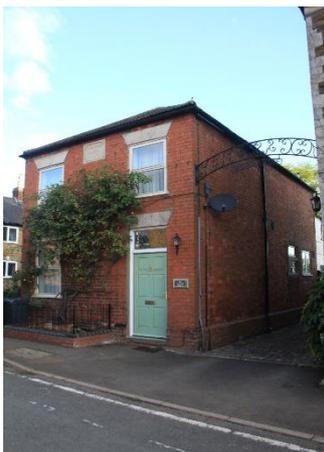
Map reference 18: Wesleyan Methodist Chapel, High Street:

Built in 1842 at the cost of £170, this chapel served the growing Methodist congregation which had by then reached over 30 members in Somerby. It is simple late-Georgian in style, constructed of red brick with limestone dressings, hipped roof, and on the front elevation, a symmetrical arrangement of three windows and panelled door (modern) and first story date stone. On the west elevation a tall window, now partially blocked, suggests it once provided light to the front of the chapel, the communion table, rail and reading desk. The chapel has recently been remodelled internally as a dwelling. (Source: Gill, Josiah, History of Wesleyan Methodism . . .' (Warner:Melton Mowbray 1909)).

Figure 21: Wesleyan Methodist Chapel, High Street, Somerby (Map Ref 18)

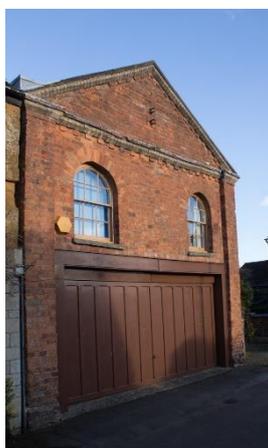
Map reference 19: Primitive Methodist Chapel, Chapel Lane:

Built circa 1863 and more recently converted to a workshop/garage on the ground floor, the chapel is constructed of red brick. Its neoclassical design, unusual in Somerby, is similar to other Methodist chapels of this period. Several neoclassical features survive, including a pedimented roof - dentils beneath, two arch headed windows with glazing bars, and, adjacent to what likely was the entrance door, pilasters on each side. The quality of the design illustrates the prominence of the Methodist movement in Somerby, whose growing congregation later required a move to a larger building on High Street. (HER: MLE22674-updated; excerpts from written notes of Reverend Spencer, Circuit minister 5 May, 1898, held by Somerby Methodist Chapel)

Figure 22: Primitive Methodist Chapel, Chapel Lane, Somerby (Map Ref 19)

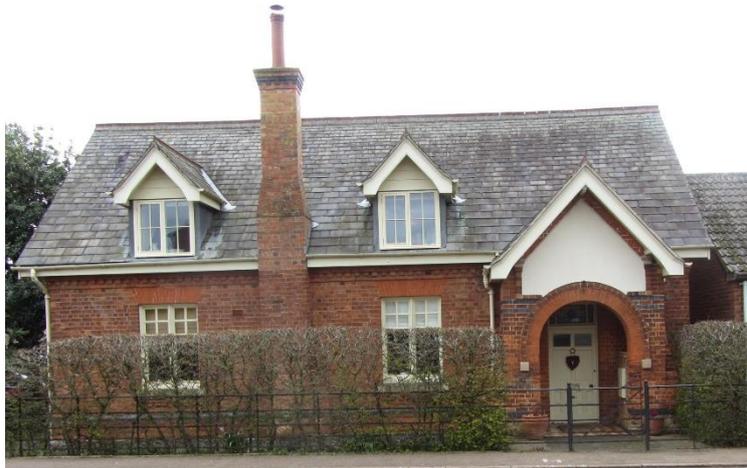
Map reference 20: Primitive Methodist Chapel, High Street:

Constructed in 1885-6 for the Royal Albert Society of Oddfellows, the hall was fully converted to a Methodist Chapel by 1898. The building is rich in Domestic Revival architectural motifs including, polychromatic brickwork, dentils, oculus window, an entrance porch with brick arch with limestone stops, tiled porch floor and stained glass window; prominent chimney stack and first storey decorative brick work. It has recently been sympathetically converted to a dwelling. (Source: Leicestershire Records Office (LRO: the Trust Minute Book of the Somerby Primitive New Church, 1892-1946; HER:MLE15353)

Figure 23: Primitive Methodist Chapel, High Street, Somerby (Map Ref 20)

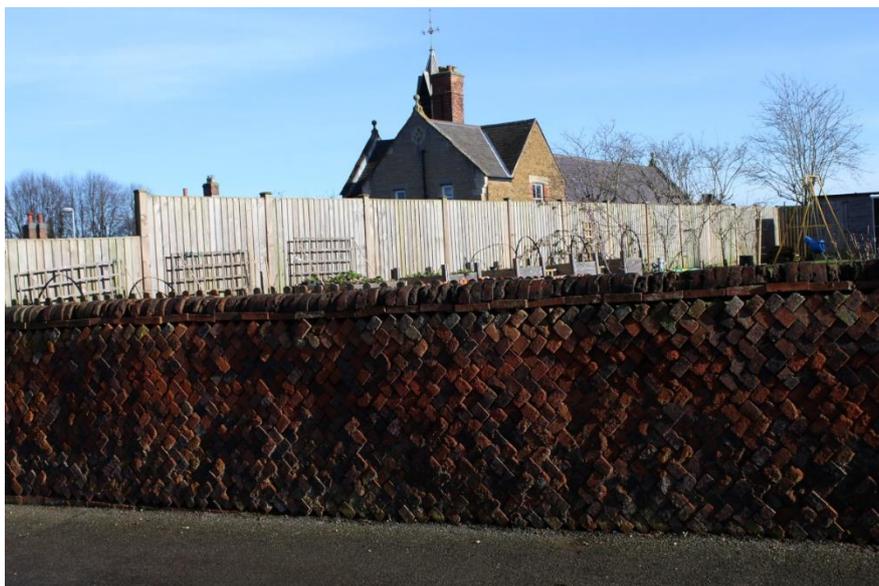
Map reference 21: Herringbone Boundary Wall, Chapel Lane:

The 14 metre length of brick walling borders Chapel Lane in the setting of Somerby County Primary School, Burley Cottage and the Stilton Cheese Pub, all Grade II listed. It is constructed using herringbone bond with no visible evidence of mortar, and with semi-circular moulded brick coping. The brick work is polychromatic, including red, grey, buff and flared bricks but without a clear pattern. Polychrome brickwork was popular during the C19 Gothic and Domestic Revival period. The boundary wall's bond and materials are similar to a low retaining wall, now much eroded, at the front of Somerby School. This suggests the Chapel Lane boundary wall was built circa 1876 at the time of the school with an historic and architectural relationship with the listed building. The wall is attractive and unusual, and marks evolution in walling materials in Somerby where ironstone is dominant. (Source: Somerby County Primary School, HE Listing: 1177755)

Figure 24: Herringbone bond Boundary Wall, Chapel Lane/High Street, Somerby (Map Ref 21)

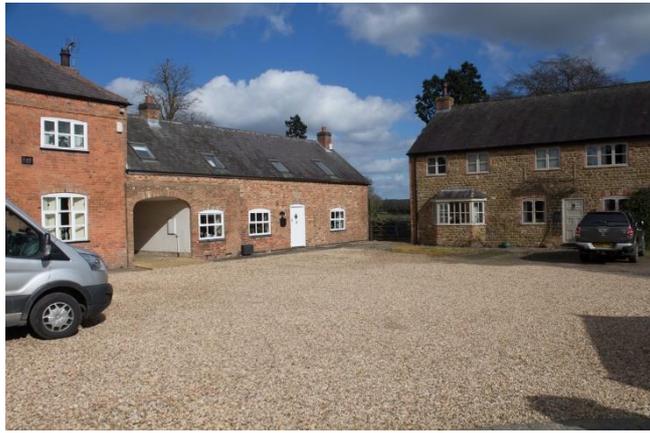
Map reference 22: Somerby Hall Farm Stable Court, High Street:

Shown on the 1885 Somerby OS map, and formerly the stable court of Somerby Hall, this series of brick and ironstone buildings reflects the past usage and organisation of services for the now demolished Hall. The site includes remnants of a 'polite' entrance gate -- limestone pillars with globe finials, once opening from the Hall grounds into the court, the remains of stables, a long barn, cow byre, a dairy and staff accommodation. Most of these structures have been sympathetically remodelled to housing. The court is enclosed by a high ironstone wall, a prominent feature of the High Street conservation area, and has a second less 'polite' brick entrance gate from the High Street. Somerby Hall was home in the C19 to Col. Frederick Gustavus Burnaby, Horse Guards, author of *A Ride to Khiva* (d.1885) and the subject of a well-known portrait by James Jaques Tissot (1836-1902) held by the National Gallery. (Source: LRO-LB 543, Local Studies Biography)

Figure 25: Somerby Hall Farm Stable Court, High Street, Somerby (Map Ref 22)

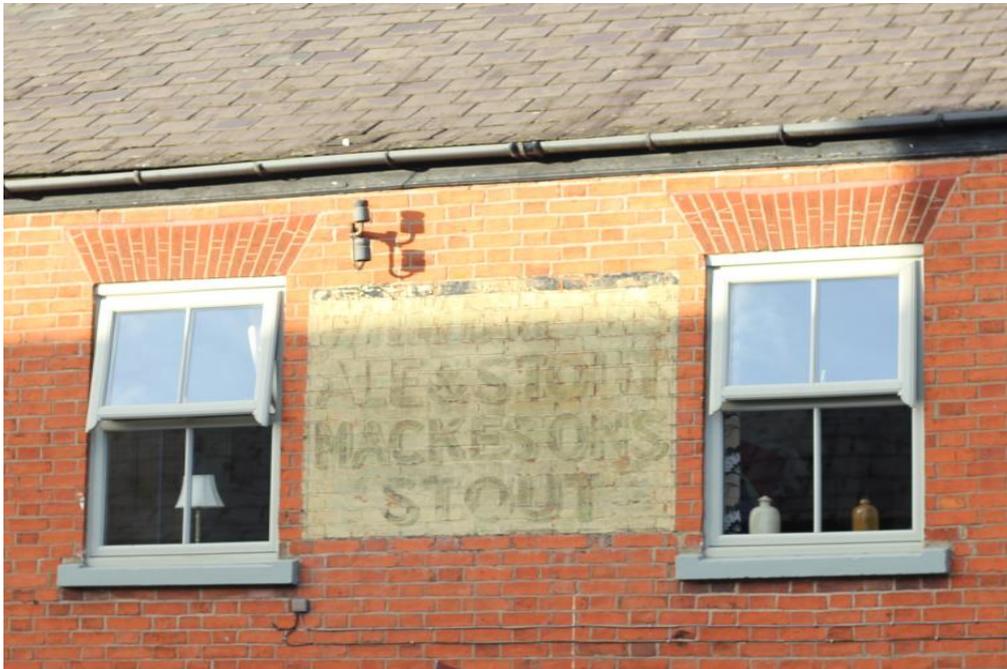
Figure 26: Painted advertisement, Old Shop, High Street, Somerby (Map Ref 23)

Located on the first storey front elevation of 42 High Street, at one time an off-licence; an early C20 painted advertisement for Makesons Stout, a 'milk' stout with added nutrition, nationally distributed beginning in 1909. It is a rare surviving artefact illustrating the character of Somerby's historic High Street at its peak as a thriving commercial centre, shown in photographs. Shops included bakeries, groceries, butcher shops, a department store, a veterinary hospital and post office amongst many others. The shops have almost entirely been remodelled to dwellings. The painted image has intrinsic value for its period design, is a rare survival, and has communal value. (Source: Somerby Remembered, Local Historical Society, 1994;)

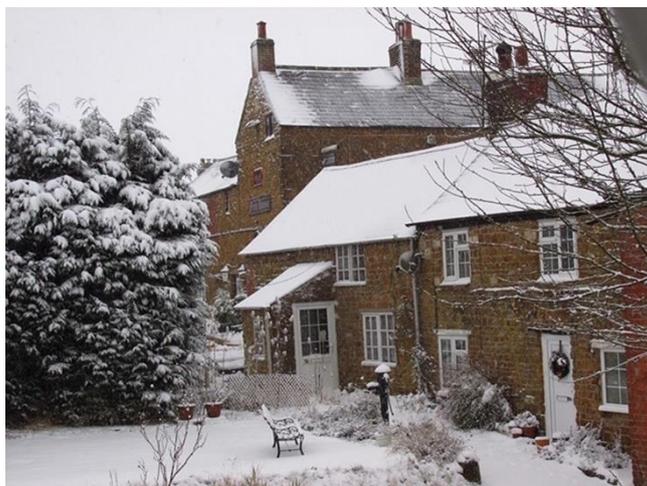
Map reference 24: Middle Stone, Fern and End Cottages, Water Pump and outbuildings, High Street:

A row of three circa C18/early C19 two bay ironstone cottages with street facing gable ends, one refaced in part with brick and extended; two brick outbuildings, one with red pantiled roof, likely functioning as a communal washhouse, store and outhouse; and also a communal well with C19 cast iron water pump. The buildings are shown on the 1885 Somerby OS map. Observations of the interior of Middle Stone cottage show a chamfered ceiling beam, remnants of timber framing marking an earlier division of space, one hearth wall with internal winding staircase with early door, and also kitchen hearth with C19 cast iron stove. The cottages and shared services are representative of similar groups of small vernacular cottages of this period in Somerby, likely housing for rural workers and now mostly demolished. (Source: 1885 Somerby OS Map)

Figure 27: Middle Stone, Fern and End Cottages, High Street, Somerby (Map Ref 24)

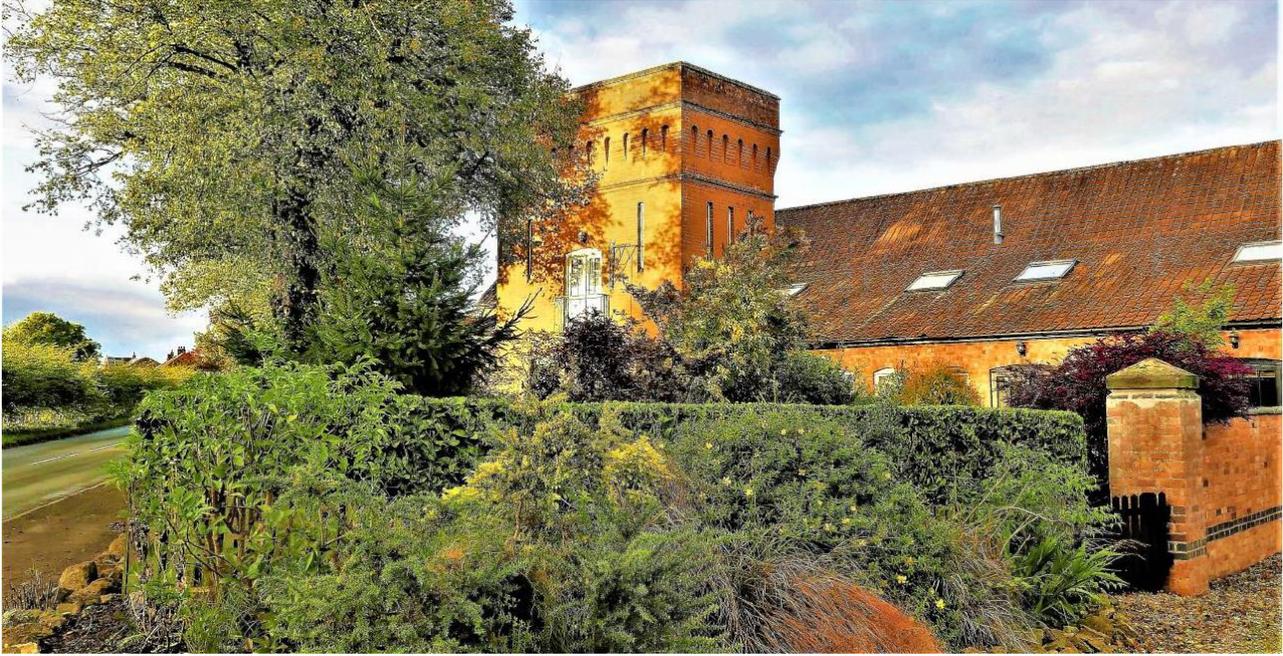
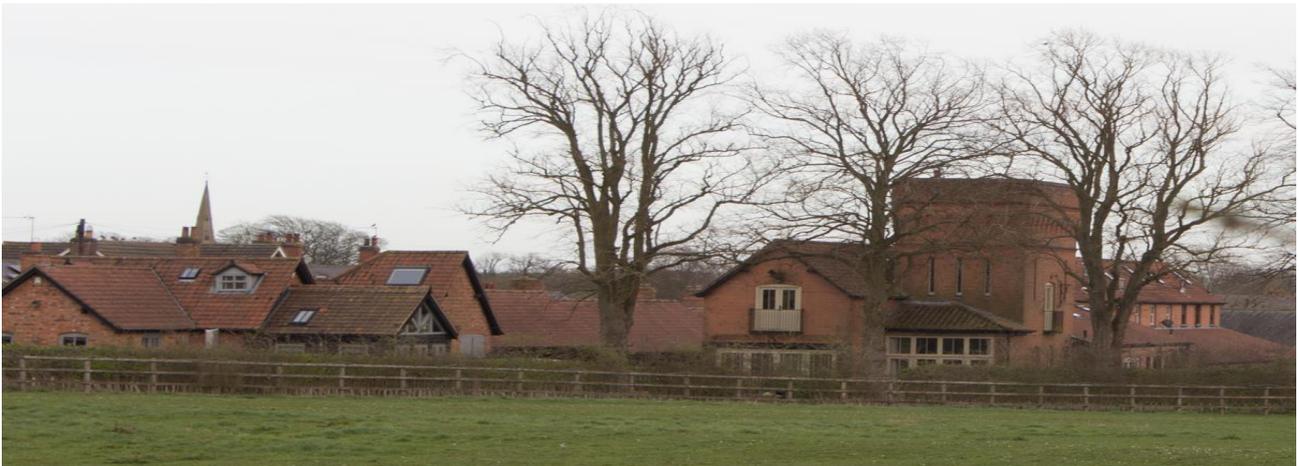
Map reference 25: Grove stables and water tower, Burrough Road:

Constructed of red brick in Domestic Revival style. Once stabling 40 horses, it features steeply pitched, red pantiled roofs and arched entrance to an inner court. The water tower, castle-like in design, with simple decorative brick work, faux arrow-slit fenestration, original wood hoist beam on north elevation; a turreted timber roof with finials was removed. The water tower is an example of C19/20 country house technological innovation; its built quality, aesthetics and prominent height make it a landmark at the village entrance; and it contributes to Somerby's on-going 'brand' as an equestrian centre.

Figure 28: Grove Stables and water tower, Burrough Road, Somerby (Map Ref 25)

Figure 29: Grove Stables and water tower buildings at right, Burrough Road, Somerby (Map Ref 25)

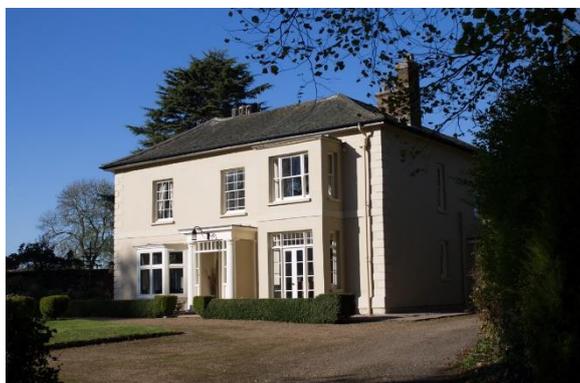
Map reference 26: Grove House and outbuildings, Burrough Road:

Late C18/early-C19, rendered ironstone, compact plan form, hipped roof of hand cut slate, string course and quoins, stone porch (later enclosed) with Doric columns and pilasters, areas of fenestration remodelled mid C19 and early C20. Internal features include central entrance passage open through first storey, cantilevered stair and balcony with ogee and trefoil decoration. Spine beams and remnant of a mullion window in beer cellars suggests incorporation of an earlier structure. A 1949 measured drawing shows room names and uses of that time. Occupied by Kathleen (nee Candy), Duchess of Newcastle (Born 1872), and Samuel Hames, builder of Grade II Vinery and stables at the Grove. A house on site is depicted in the 1816 Boyce Map of Melton Mowbray. (British Library) and 1885 Somerby OS map; a 1950's details of sale document states a building date of circa 1670.

Figure 30: Grove House, Burrough Road, Somerby (Map Ref 26)

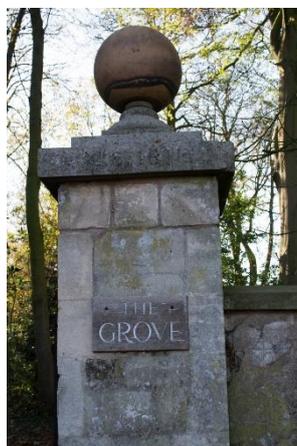
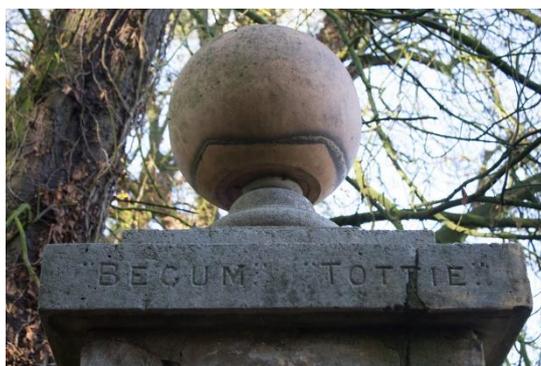
Map reference 27: Grove house entrance gate, Burrough Road:

Entrance gate with ironstone pillars with globe finials, date marked 1879; cornice carved with the names of winning racehorses owned by Major Augustus 'Sugar' Candy (d. 1911) occupant of Grove House. Important to the equestrian heritage of Somerby the horses names are: Rosebud, Cracker, Countess Parkmount, Begum, Tottie, Rob Roy and Mary Ann. (Source: Somerby Remembered, 1994)

Figure 31 a, b: Grove House entrance gate, Burrough Road, Somerby (Map Ref 27)

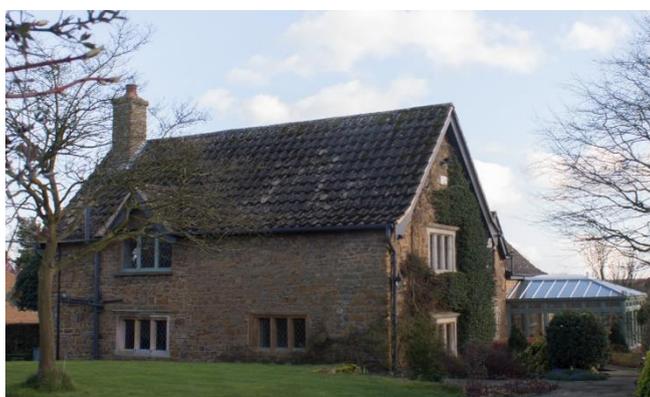
Map reference 28: Charity House, Chapel Lane:

C17 timber framed cruck-built house encased in ironstone, it is the most southerly example of a cruck house located in Leicestershire. The dwelling comprises a north-south range with an east west cross-wing, later extended. A tree ring analysis suggests two felling periods present in the structure, 1613-1638 and 1690, with timber from the 1613-38 felling likely reused from an earlier structure. A 1961 recording suggested parts of the structure were C15/16 in origin. Archival evidence at this time is sparse, but Charity House is considered of historic and architectural merit. It is sited at the northern end of recently identified earthworks of medieval Somerby and a hollow way, and perhaps contemporary with the earlier village layout.

Figure 32: Charity House, Chapel Lane, Somerby (Map Ref 28)

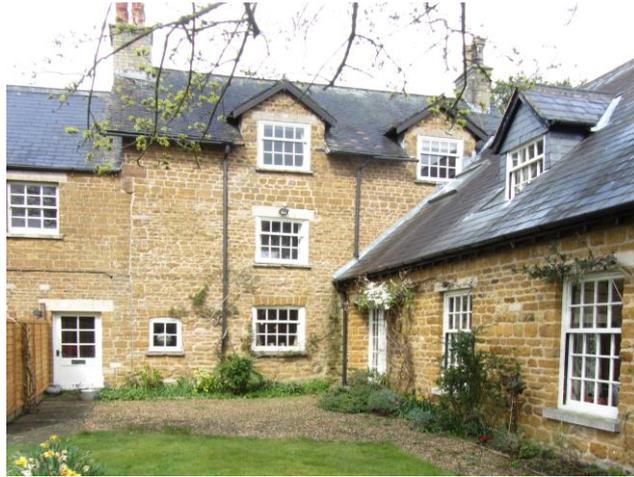
Map reference 29: Church House, attached wing and outbuilding , Church Lane:

Circa early C17, with attached wing with evidence of alterations, and four bay outbuilding, adjoining Grade I Somerby Church and church yard and in the setting of Grade II Somerby House and service court. The three-storey east wing, with cellars and attics, is of coursed rubble stone; south (front) elevation with symmetrical fenestration, several remaining chamfered sills, and two dormers; the two storey attached wing possibly of refaced coursed and squared ironstone. A cross wing was added in the mid-1990's.

Two ground floor rooms, possibly an early kitchen-hall, partitioned to add a parlour, with chamfered ceiling beam crossing both rooms with concave stops; north end of the hall, a dog leg stair rising to the top and also aligning at the ground floor with a blocked door to steps leading to cellars, with a blocked opening and sill suggesting a window. An inglenook hearth with recesses and two-light window; the south recess remodelled to hold circa C18-early C19 wooden desk, a storage cupboard above in the space of the bake oven.

The original entrance to Church House, entered from the court, is suggested by a passage between the hearth wall of the east wing and west wall of the attached wing. The passage leads to an internal squared headed wooden door, a single entrance to the hall. (Source: 1885 Somerby OS Map)

Figure 33: Church House, Church Lane, Somerby (Map Ref 29)

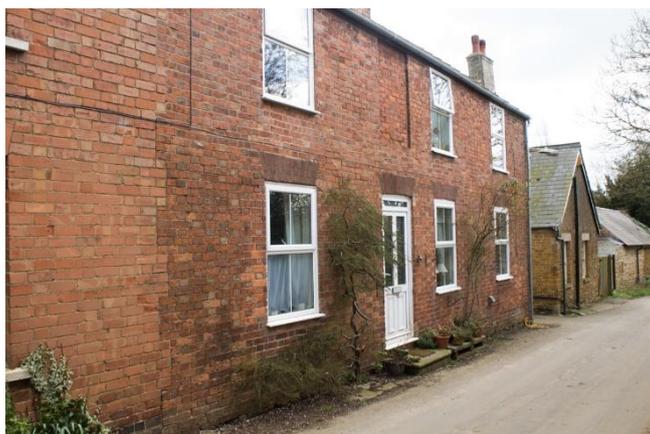
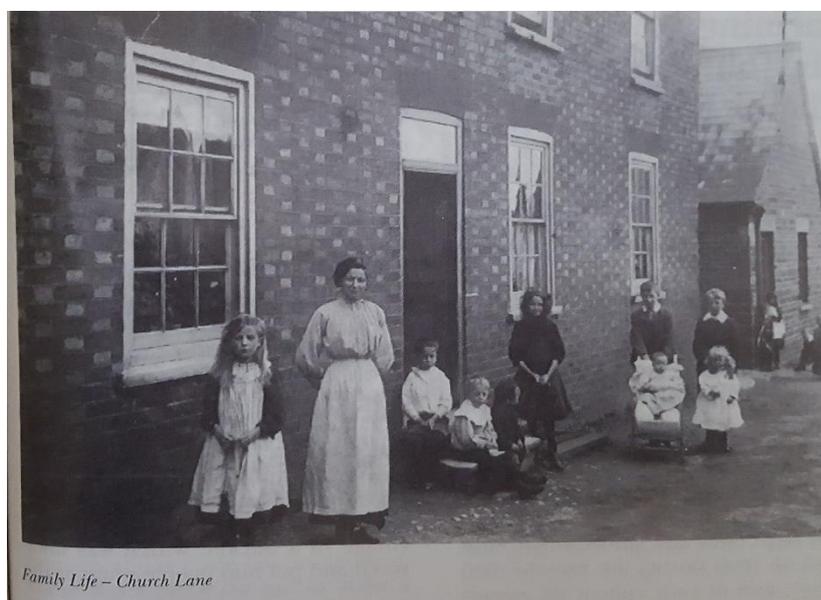
Map reference 30: Terraced cottages, Church Lane:

Shown on the 1885 Somerby OS map, mid-C19 terraced cottages of two storeys constructed of red and buff brick arranged in an unusual decorative pattern. The cottages have been enlarged internally and original sash windows and doors replaced. They are in the setting of Grade I Somerby Church and overlooked by the churchyard and the south facing Perpendicular style church window; and also in the setting of Grade II Somerby Farmhouse. They represent an example of working family, likely tenanted, accommodation in the village during that period. The gable end of the cottages and north wall of adjacent Church House enclose a small lane leading to the main entrance of the Church from Church Lane, a surviving feature of an earlier spatial organisation of the village. (Source: Somerby Remembered, 1994)

Figure 34: Decorative brickwork on terraced cottages, Church Lane, Somerby (Map Ref 30)

Figure 35: C19 image of a family taken outside the terraced cottages on Church Lane, Somerby, highlighting the decorative brickwork (from “Somerby Remembered”) (Map Ref 30)

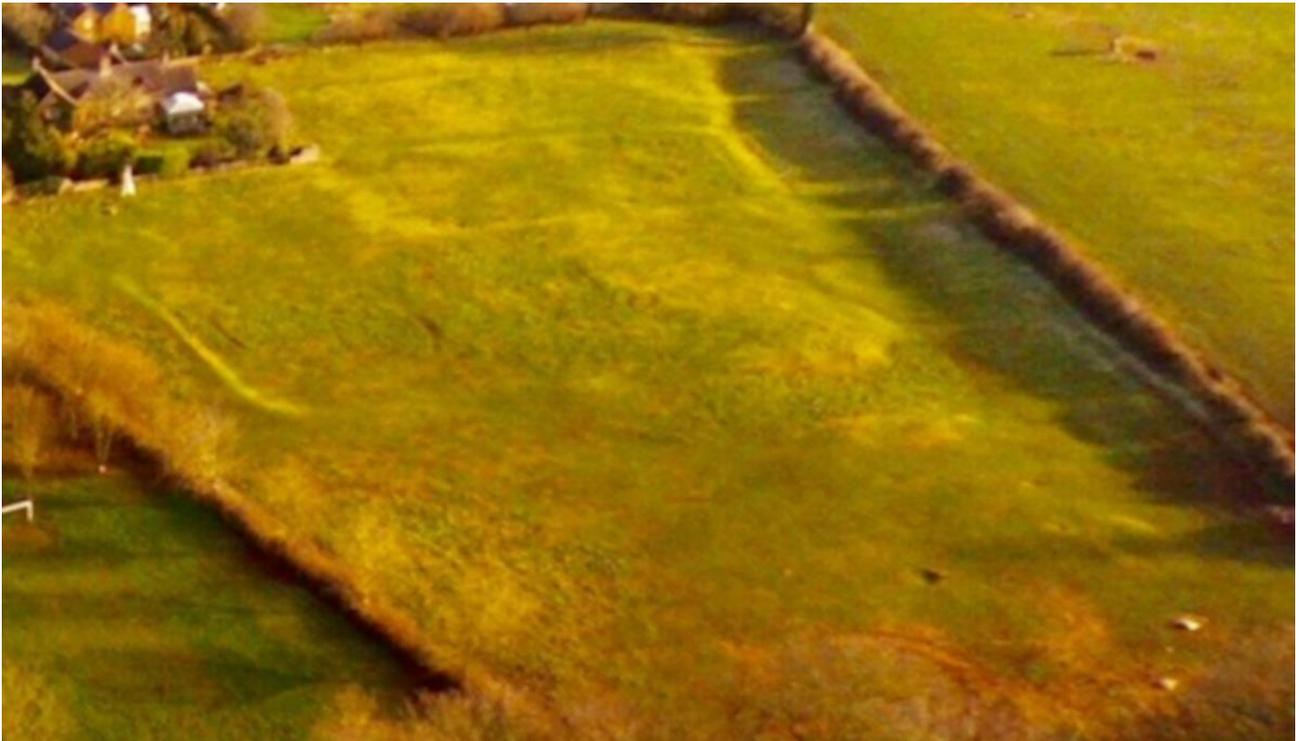
Figure 36: Croft Field, High Street, Somerby (Map Ref 31)

A distinct area of visible remains of a medieval toft and croft settlement and hollow-way identified by the Neighbourhood Plan, with guidance, notes and sketches provided by Robert F. Hartley, author of *The Medieval Earthworks of North-East Leicestershire* (1987); recently excavated by Leicester University Archaeological Services. The earthworks in a green field to the south of Somerby High Street, is in the setting of Somerby Grade I Church. Preliminary findings suggest it is a complex site however the report of the site evaluation conducted in April 2017 was not available at the time of this writing. (Source: HER MLE222700]

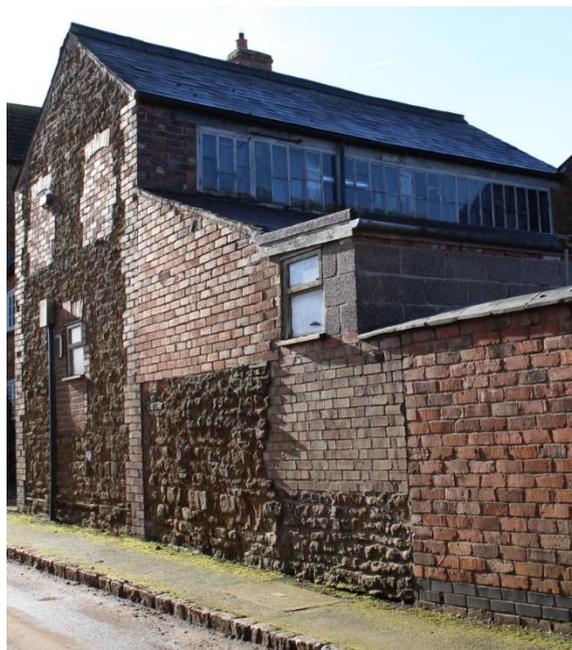
Map reference 32: Early industrial building, Manor Lane:

Mid-C19 brick building attached to Grade II Manor Farmhouse. Notable for its fenestration which at the first storey comprises a panel of 24 lights whose function would have been to light a work or production space. Somerby has been identified as an early Midlands industrial village and White's gazetteer lists several businesses in Somerby, including knit hosiery manufacture, for which this work space would have been useful. Somerby did not progress as an industrial centre, therefore this feature is a rare local asset representing a piece of Somerby's economic history. (Source: Everitt, Alan, *Landscape and Community in England*, (Bloomsbury, 1985, p. 123); White, William, *History Gazetteer and Directory of Leicestershire and the Small County of Rutland*, 1846, (p.258)

Figure 37: Former Industrial Building, Manor Lane, Somerby (Map Ref 32)
