APPENDIX 10

LOCAL NON-DESIGNATED HERITAGE ASSETS

Assessments: Somerby Parish Local Heritage: Buildings, artefacts, parklands and gardens (using Historic England Guidance)

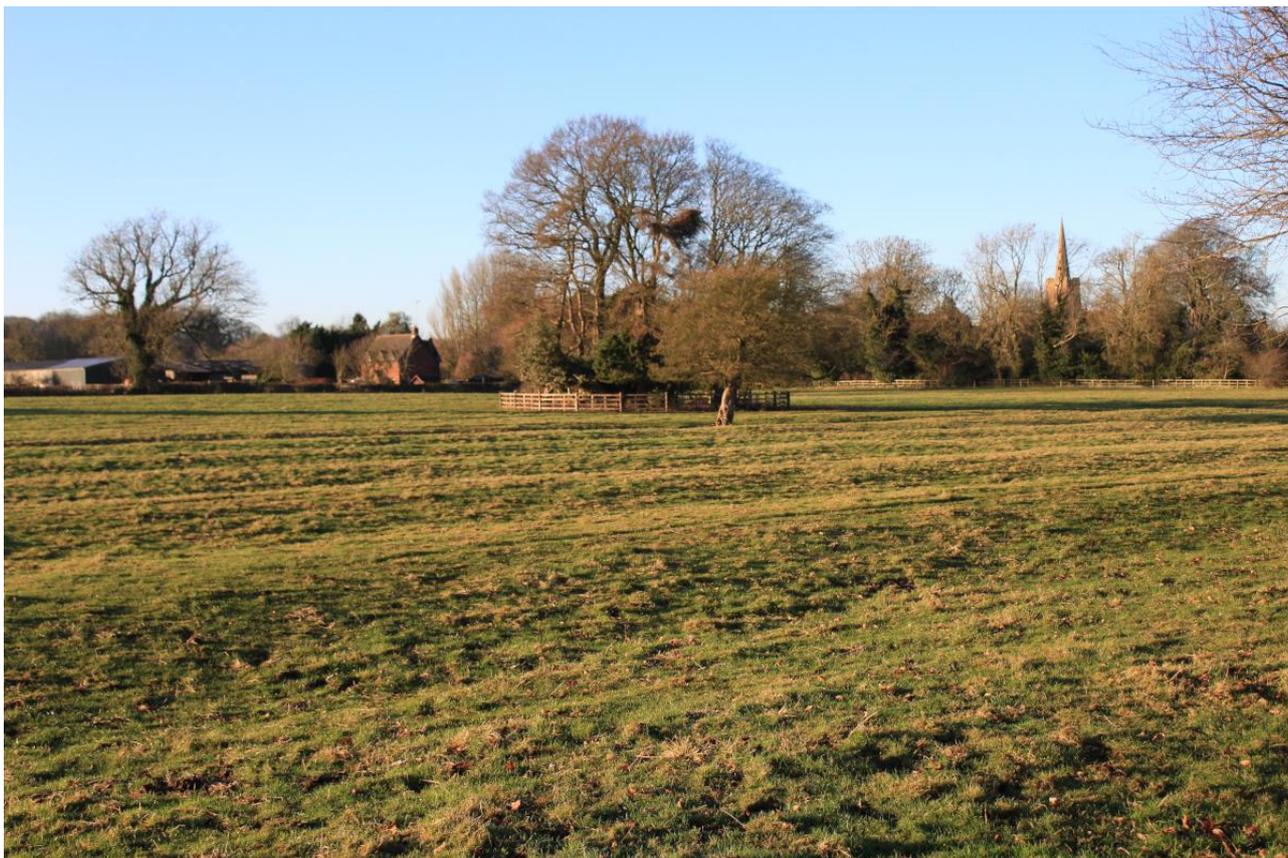
Figure 38: Somerby House Parkland, Owston Road, Somerby (Map Ref 33)

The park land has extensive ridge and furrow, once part of Somerby's medieval field system, well preserved due to continuous use as pasturage. A beech tree grove borders the park along the Owston Road. Within the park, a circular group of deciduous and conifer trees planted post WWII by Captain Tatlock Hubbard MC, occupant of Somerby House, other scattered veteran trees, and a disused brick water tower, an 'eye-catcher'. The visual juxtaposition of the park's ridge and furrow and medieval Somerby church tower and spire at the village entrance contributes to the broader

conservation area and character of the village. Public views of the park land are available from the Owston Road and Footpath D74; the garden is private. Source: Historic England Listing: 1061247.

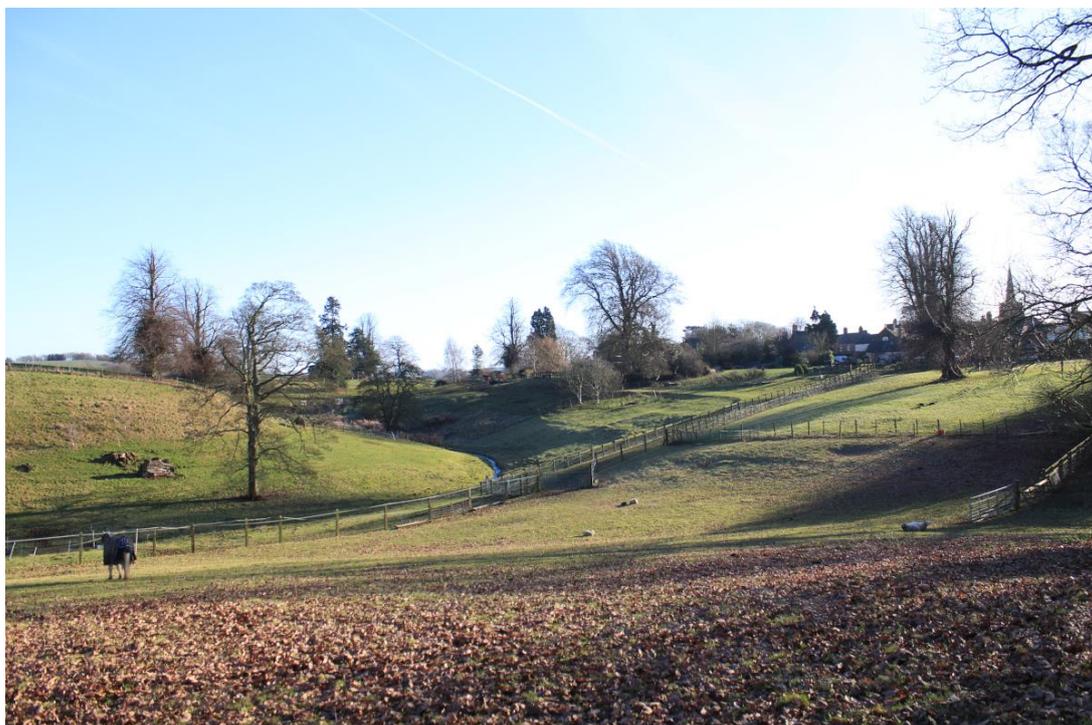
Figure 40: Looking South towards Somerby, across Somerby Hall Parkland including trees subject to a Tree Preservation Order (Map Ref 34)

No records of the evolution of the park were found. However, it is an example of C18 'naturalized' landscape design, with pleasantly varied pastoral topography and trees under a Tree Preservation Order. There are belts of notable mature trees and sight lines appear orchestrated to provide sweeping views of the Hall (now demolished), Church, east slopes of Burrough Hill Fort (SAM) and towards nearby Pickwell Manor park. There are a number of important veteran specimen trees, recently estimated to be well over 250 years old, suggesting the park originated in the C18. Public views of the park are had from the Pickwell Road, and from the Leicestershire Round and Footpath D68 which cross it. (LRO:LB-543 Local Studies Biography; 1885 OS Map; LCC, Tree Protection estimate, Feb. 2019)

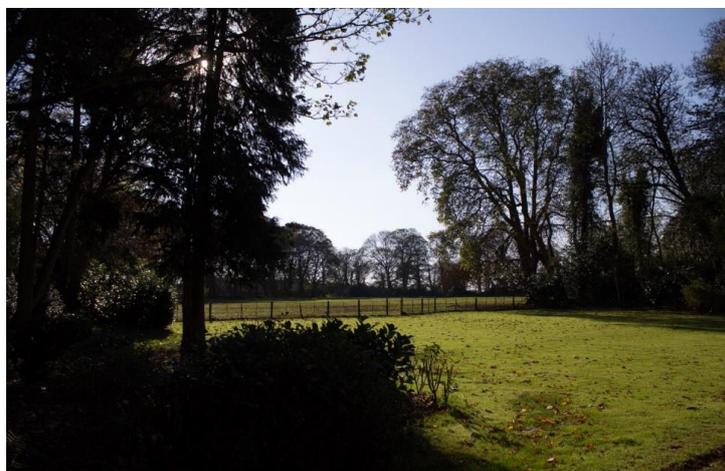
Figure 42: Parkland and gardens of the Grove, Newbold Lane, Somerby (Map Ref 35)

Forming part of a small estate described in White's 1844 *'History, Gazetteer and Directory of Leicestershire and Rutland'* as 'a neat mansion with tasteful grounds', the park and gardens contribute to the setting of the Grade II Vinery at the Grove (HE: 1436571) and for Grove House and outbuildings (HER: MLE:15305 and MLE:22266). Grove park land is characterised by native varieties of approximately 200 trees and also notable specimen trees, many veterans (some pre-dating the visible house) and two designed avenues. Many are protected by a Tree Preservation Order. Maps and photographs show that the C19/early-20 spatial organisation of the park, gardens and garden buildings remain mostly unchanged. The 1860 diary of Edward Barnett, occupant, provides a record of life at the Grove, including observations on hothouse use, gardening and plantings. Areas of the park land are designated as Priority Habitats by Natural England with owls, raptors, bat species and mammalian wild life observed. The park and gardens are publicly visible in full and parts from the Newbold Lane, footpaths D74, D70, the Leicestershire Round and a accessible by a bridleway through the park. (Source: 1885 and 1904 Somerby OS Map; garden photographs, Somerby Remembered, 1994; Hames Family Archives; Leicestershire Record Office: Diary, 1860, Edward Barnett, DE5688; LCC Tree Protection estimate, February, 2019)

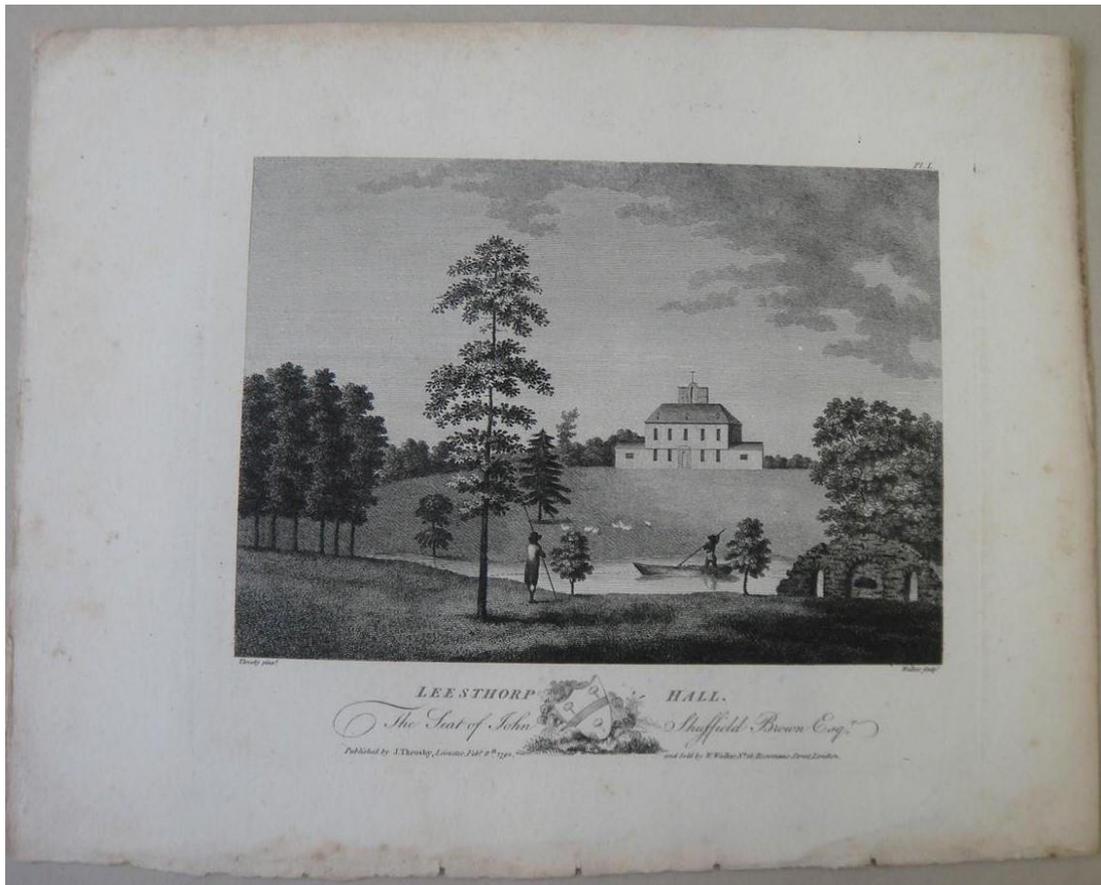
Figure 44: C18 drawing of Leesthorpe Hall and Parkland (Map Ref 36)

The central feature of Leesthorpe park is an irregular shaped lake, likely man-made. A circa 1792 drawing of Leesthorpe Hall shows the lake at this date, a feature set within a large, well established landscape park of C18 design. A rustic stone artificial grotto, placed to overlook the lake, the house and people leisurely boating depicts the 'Taste' of Esquire John Sheffield Brown, then occupant.

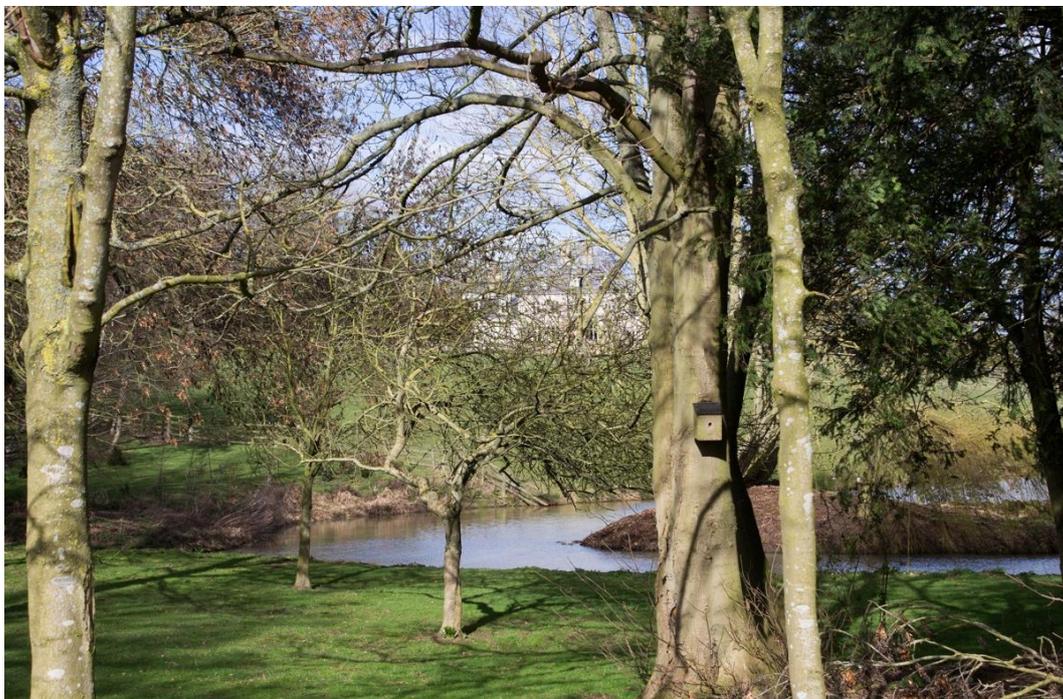
Figure 45: Leesthorpe Park lake with Hall in background. (Map Ref 36)

At present the park land surrounding the lake is more densely wooded, set out with informal pathways. Existing mature and veteran trees are incorporated into more recent plantings creating a strong vertical element to the park's design, reflections in the lake and glade-like pockets of light amongst the scattered trees. Attractive to wildlife, Natural England has designated the woodland as a Priority Habitat. The park and lake are visible to the public from the Leesthorpe Road. (Source: Print, Leesthorpe Hall, the seat of John Sheffield Brown, Esq., 1792, Walker, ex J. Throsby, Leicester Amazon print); Historic England Listing: 1177591)
