APPENDIX 9 – BUILDINGS AND STRUCTURES OF LOCAL SIGNIFICANCE

LOCAL LIST: NON-DESIGNATED HERITAGE ASSETS

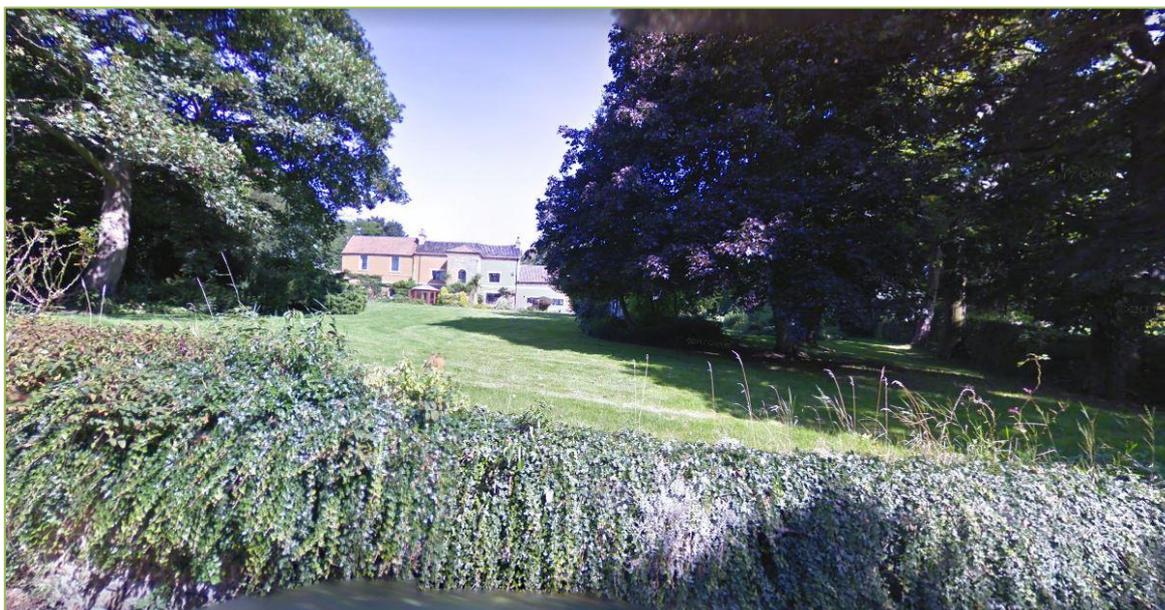
1. Wartnaby Hall, Wartnaby

A large, attractive dwelling located within the heart of Wartnaby village. Melton Borough Council's Conservation Area Appraisal identifies the Hall as "a building noted as being of special interest located directly opposite the Church set in magnificent and well landscaped gardens". The appraisal also notes that "It is said that King Charles II took breakfast at Wartnaby Hall with the then owner a Mr. Hackett" and that "it was occupied by military forces during the second world war". The age of the original fabric of the house is unclear but it is likely that a house has stood here since time immemorial, and there are 12th and 13th century remains in the grounds. The present fabric is mainly 18th and 19th century but with a striking Art Deco entrance atrium which was added when the house was reduced in size after the Second World War, during which time it had been occupied by Italian prisoners of war. An arcaded wall within the gardens was formerly part of the Ballroom and forms part of the Listing of Tower Cottage to the North, although the Hall itself is not listed.

Age	Unknown	Largely 18th and 19th century with older origins
Rarity	High	Wartnaby Hall is a unique property.
Aesthetic Value	High	Wartnaby Hall is a highly attractive building set in beautiful grounds. It is integral to the beauty and character of Wartnaby village.
Group Value	Yes	It has some association with the neighbouring Tower Cottage which is Grade II listed and it is local legend that there is a tunnel from the Hall cellar to the Church (although there is no proof for this).
Evidential Value	Yes	Noted as being a building of special interest in Melton Borough Council's Conservation Area Appraisal.
Historic Association	Yes	It is said that King Charles II took breakfast at the Hall with the owner of the time a Mr Hackett.
Archaeological Interest	Yes	The age of the property and remains within its grounds are expected to be of archaeological interest.
Designed Landscapes	Yes	The gardens and grounds are an integral part of Wartnaby Hall's character and beauty.

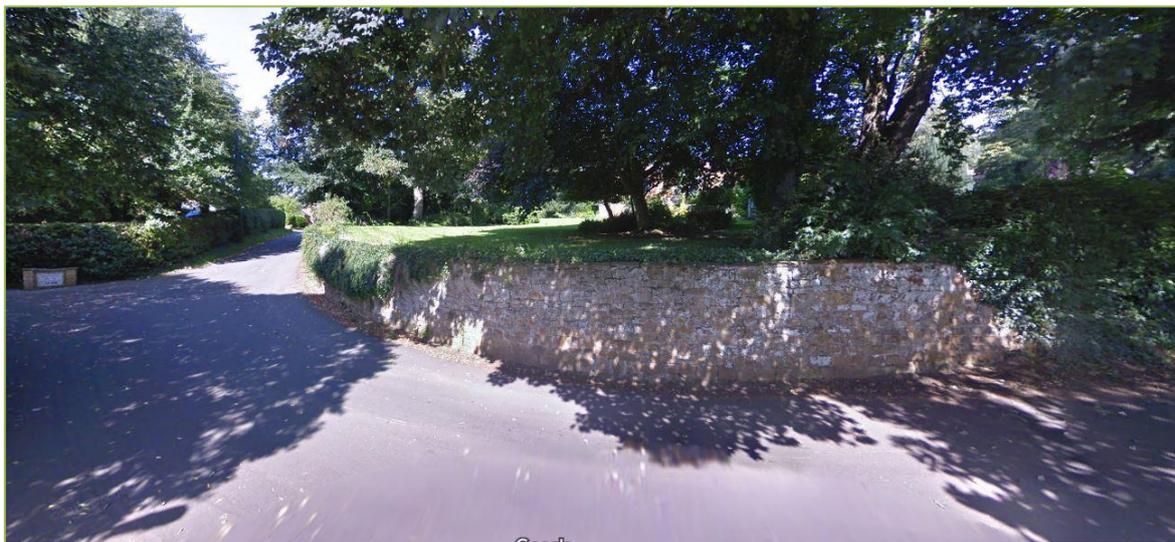
Ironstone wall, Wartnaby Hall

This is the ironstone wall that runs along the side of the main street from the corner to the back of the stone outbuildings of "Normanton's Yard". The wall forms part of the boundary to Wartnaby Hall's grounds and is an important and attractive feature of the village streetscape. The wall varies in height from approximately 6 to 8 feet high from the level of the road and retains the higher ground of Wartnaby Hall's garden. In places the wall is capped with stone coping stones, in other places it has no coping stones. The stone and mortar is crumbling and in places is likely to require maintenance or repair in the future. There is a brick arched doorway at the Western end which has steps leading up into Wartnaby Hall's gardens. New iron railings have been added in 2017 atop the curved section of the wall on the corner. The wall should be preserved and repairs should be carried out with matching, local ironstone using traditional lime mortar so as not to detract from the attractiveness of the wall. Removal of the wall or replacement or repair with different or modern materials should be avoided.

Age	Unknown	Exact age is unknown but it is an historic ironstone wall.
Rarity	Medium	The height and curve of the wall are unique within the parish. The wall is a prominent feature of Wartnaby village and although there are other similar ironstone walls within the parish (the walls bounding the road adjacent to Hall Farm, Holwell being the most notable) they do not form such an integral part of the street scene and are not as important to the character of the village.
Aesthetic Value	Medium	Constructed predominantly of the local ironstone the wall is attractive and matches the numerous ironstone buildings within the village.
Group Value	Yes	Association with Wartnaby Hall, which although not a listed building is a building noted of being of special interest in Melton Borough Council's Conservation Area Appraisal for Wartnaby and is itself included within this Neighbourhood Plan's Local List.
Evidential Value	None known

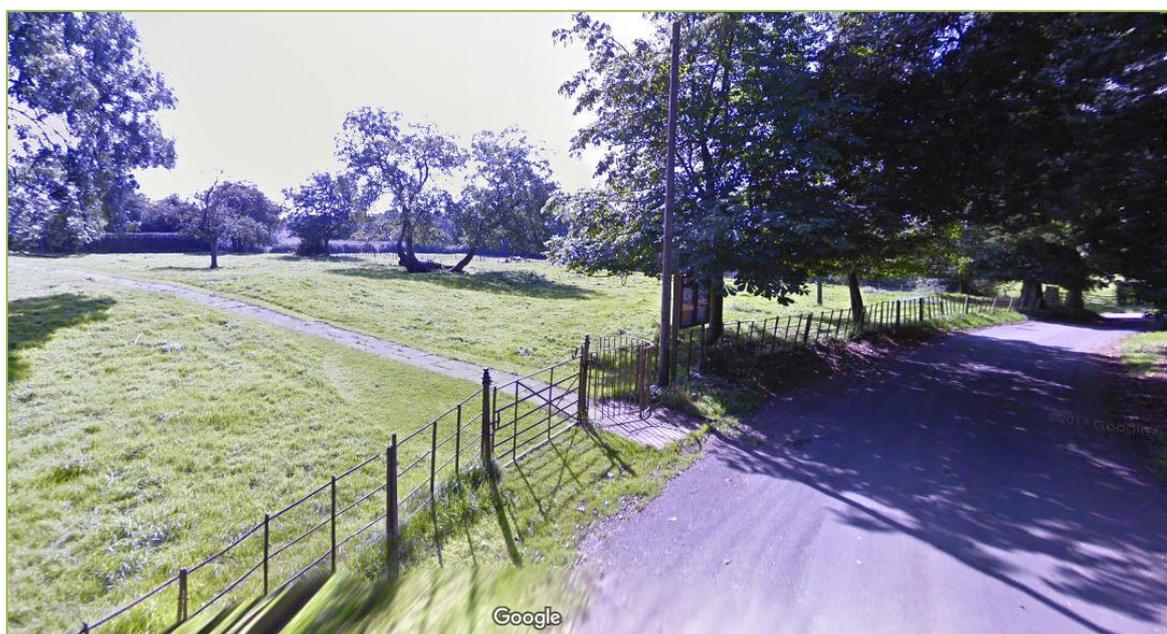
3. Iron railings and kissing gates, Wartnaby

These are the railings running down the side of the main street that form the boundary of the grass paddock between the road and the church. The railings run down the side of the road as far as the corner. There is a wrought iron kissing gate that provides access to the public footpath that leads to the church. There is also a wrought iron field gate adjacent to the kissing gate. The railings should be preserved and any future repairs or renewals should be carried out with similar style fencing.

Age	Unknown	
Rarity	High	Railings of this age are quite rare within the parish.
Aesthetic Value	High	Despite their poor condition, the railings are an important and attractive part of Wartnaby's historic street scene.
Group Value	Yes	There are iron railings of the same type and age between the two grass paddocks adjacent to the Church.
Evidential Value	None	
Historic Association	None	
Archaeological Interest	None	
Designed Landscapes	None	
Landmark Status	None

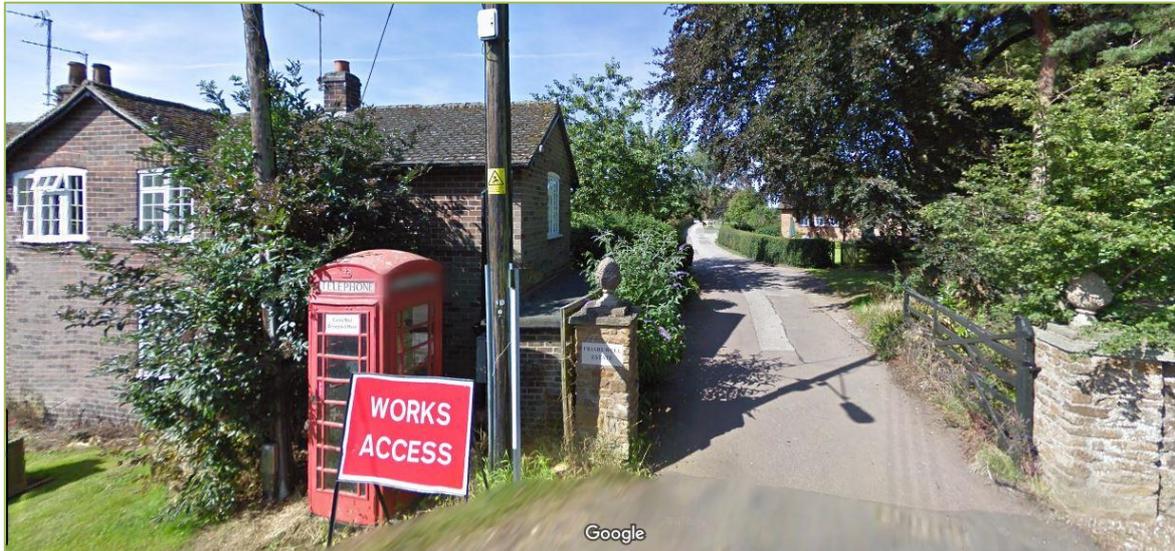
4. K6 telephone box, Wartnaby

Red telephone kiosk, now defunct and at present time being used as a book store. The kiosk is located close to the entrance gates to Friars Well Estate. Cast iron, square kiosk with domed roof. Unperforated crowns to top panels and glazing bars on windows and doors.

Age	Unknown	Telephone kiosk, Type K6. Designed 1935 by Sir Giles Gilbert Scott. Made by various contractors.
Rarity	Low	Holwell and Ab Kettleby also have K6 type red phone boxes - both of which are Grade II listed.
Aesthetic Value	Medium	
Group Value	None	
Evidential Value	None	
Historic Association	None	
Archaeological Interest	None	
Designed Landscapes	None	
Landmark Status	None	
Social & Communal Value	Yes

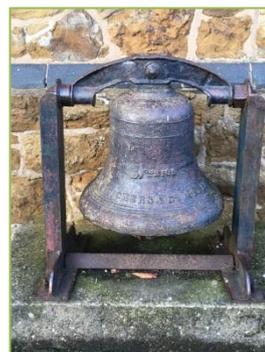
5. Ab Kettleby School Bell

This is the oldest object in the school as it was cast in 1860 two years before the building of the school started. The bell originally hung within the old school itself and was rung by means of a rope. At a later date it was moved to the outside of the old school building where it currently stands on a supporting frame allowing the clapper to be rung by hand.

Age	1860	Cast by Naylor Vickers & Co. - Bell No.2105
Rarity	High	This bell was installed in the school when it was built in 1862.
Aesthetic Value	High	The bell is an important and historical part of the village school.
Group Value	None	
Evidential Value	None	
	Known	
Historic Association	Known	
Archaeological Interest	None	
Designed Landscapes	None	
Landmark Status	None	
Social & Communal Value	Yes	The bell has been an important part of the village school from the day the school opened its doors to local children and many locals have fond memories of the bell being part of their school experience.

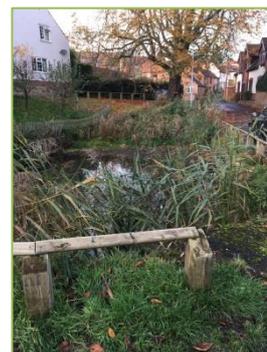
6. Ab Kettleby village pond

Situated in the heart of the village next to a large horse-chestnut tree. The pond has a natural source of water from the spring close by and was designed with a sloping side to allow easy access for horse and cart entry. In the past the village was self-supporting with its own trade workers including a wheelwright who may well have used the pond to swell the wood in the wheels built to firm them up.

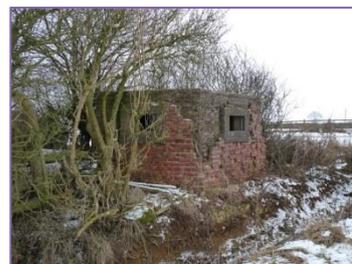
7. Landyke Lane WW2 Pillbox, Holwell

Type 22 pillbox shuttered in brick externally (much of which has fallen away) and wood internally has pre-cast concrete externally stepped embrasures with rectangular concrete shelf with rounded corners below. The half-height entrance is flanked to either side by pistol loops. Brick built cruciform AR wall/pillar with rounded corners in centre. Rounded corners to entrance internal and external. Corrugated asbestos to underside of slab roof. Overall condition fair.

Age	c.1940	
Rarity	Moderate	One of two in the Plan Area. Only 15 are known in Leicestershire (Pillbox Study Group, http://www.pillbox-study-group.org.uk/)
Aesthetic Value	Low	
Group Value	None	
Evidential Value	High	
Historic Association	High	Of local history value (including living memory of use and personnel)
Archaeological Interest	Moderate	
Designed Landscapes	None	
Landmark Status	None formal	Recorded and mapped by e.g. Defence of Britain Archive, Council for British Arachnology

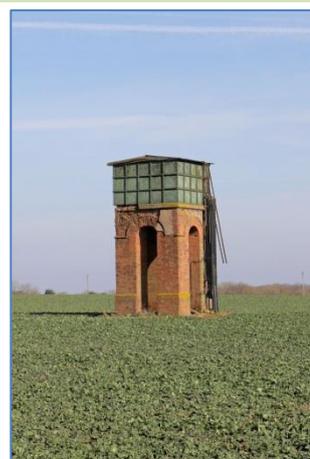
10. Water tower, Holwell

Cast iron tank supported on brick pilasters, at high point above the village in farmland.

Age	Early 20 th century	
Rarity	High	Only example in the Plan Area; one of ?two in the Borough
Aesthetic Value	Low	
Group Value
